FINAL REPORT

STRUCTURAL RESPONSE TO SONIC BOOMS

FEBRUARY 1965

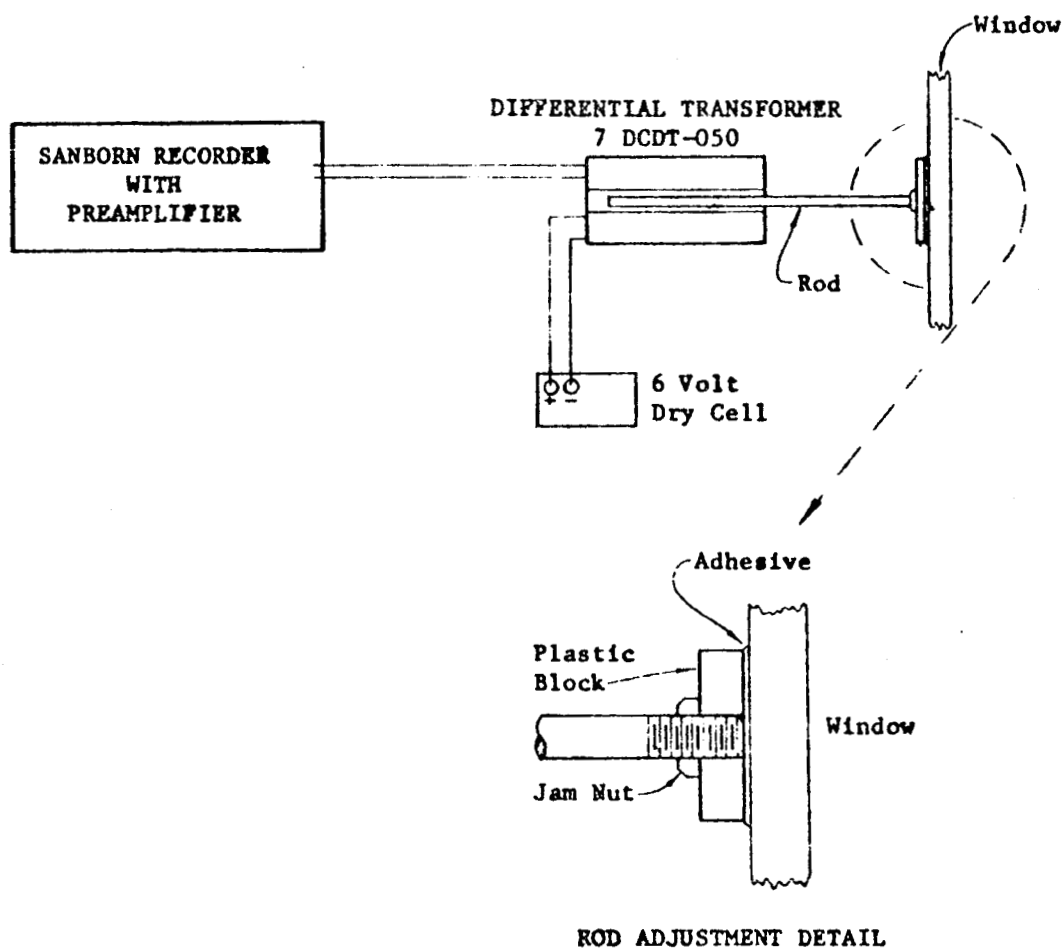
Figure 1. Instrumentation System

The instrumentation system for the measurement of dynamic deflection of the windows is shown as Figure 1 on following page, and was the same as for the first series of tests; a small high frequency differential transformer coupled to a Sanborn recorder. Calibrate deflection for this test measured 24 mm, producing a displacement formula of $y = .00278$ inch/mm of recorder deflection. Examples of deflection recordings are included herein as pages 18, 19 and 20.

The Sanborn recorder has a heated stylus and a high gain preamplifier. The frequency response depends upon the deflection of the stylus, but is flat to around 90 cps which is quite adequate since the window frequencies are around 20 cps.
